# VEHICLE INSPECTION REPORT

**DK66KAX**

## Man TGS 26.360

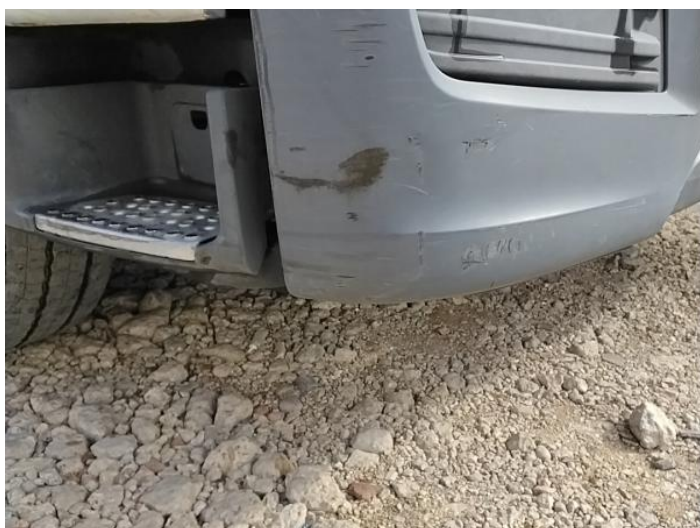
1: Bumper Front Moulding  
Scuffed (Unpainted)  
UpTo 100mm

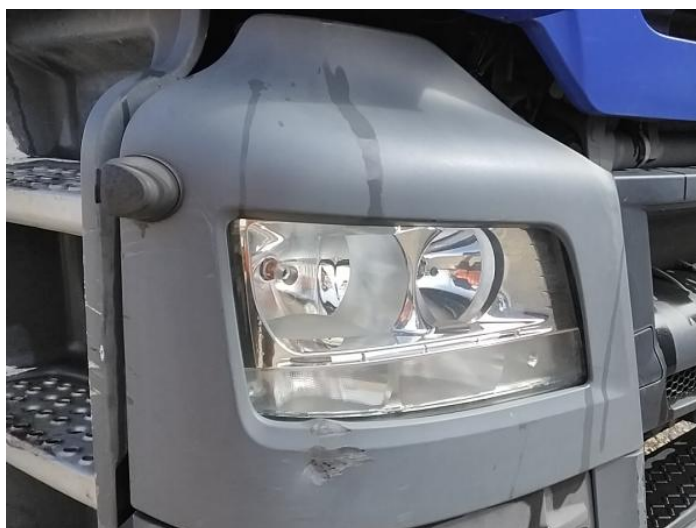
2: Fog Lamp Surround os  
Scuffed (Unpainted)  
UpTo 100mm

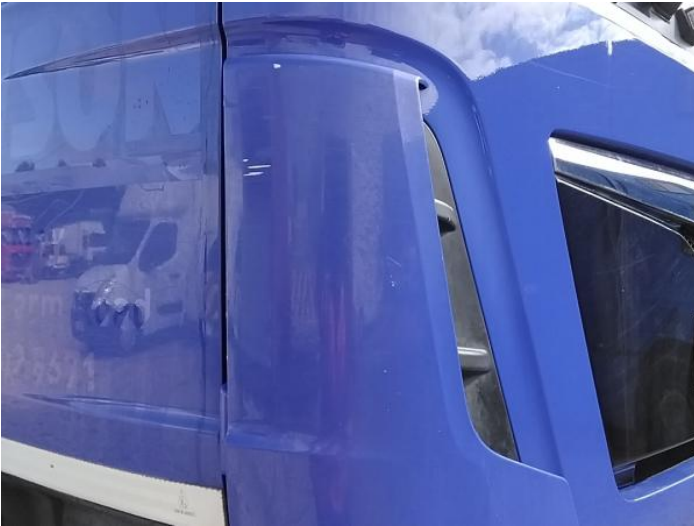
3: Wing osf  
Scratched  
UpTo 25mm Thru Paint

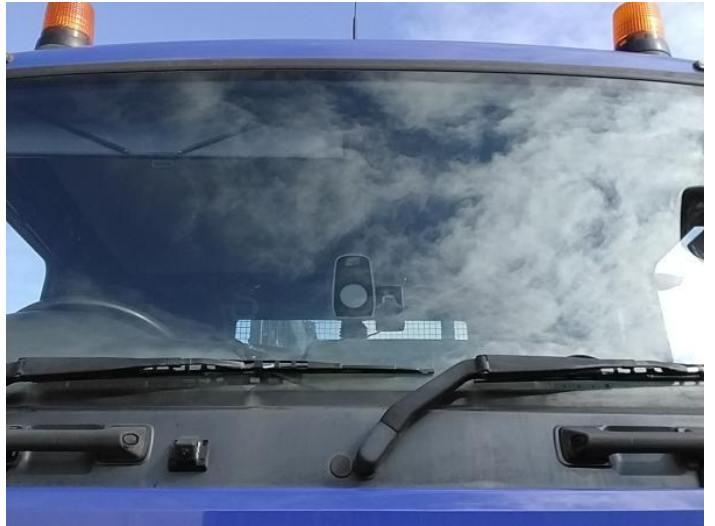
4: Screen Front  
Chipped  
UpTo 10mm

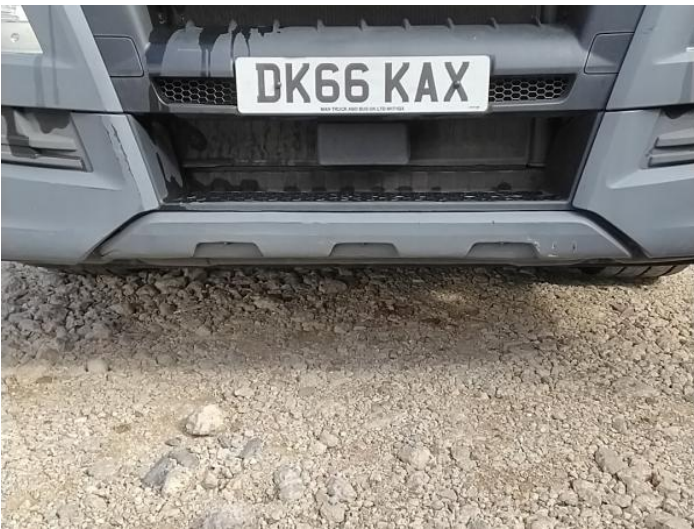
5: Bumper Front  
Cracked  
UpTo 25mm

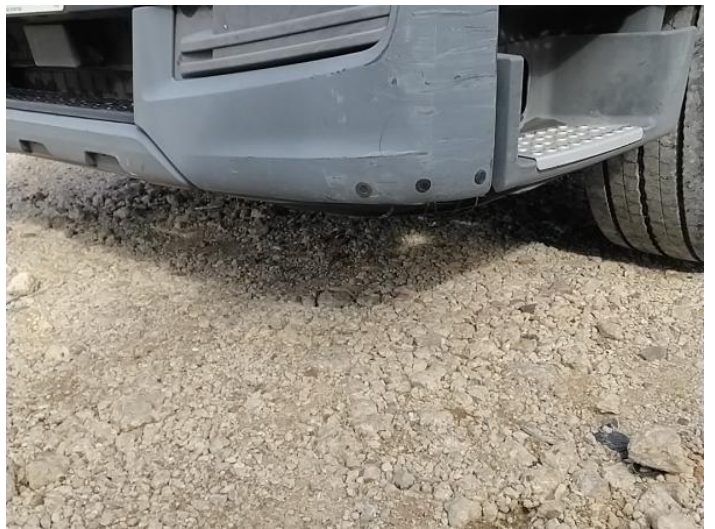
6: Bumper Front Moulding  
Scuffed (Unpainted)  
UpTo 100mm

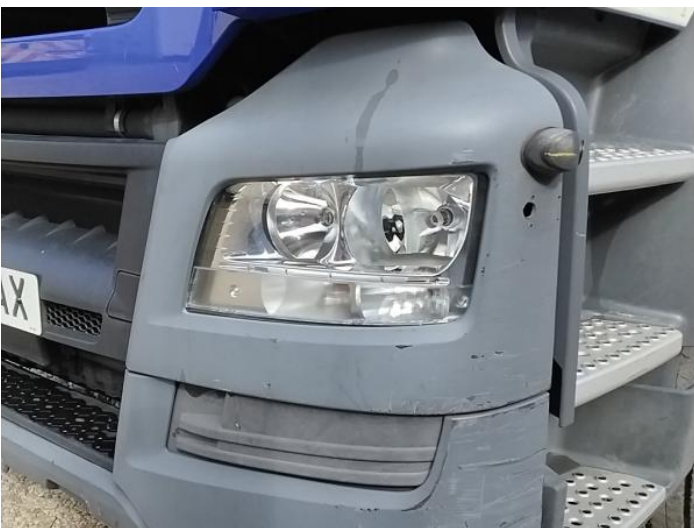
7: Fog Lamp Surround ns  
Scuffed (Unpainted)  
UpTo 100mm

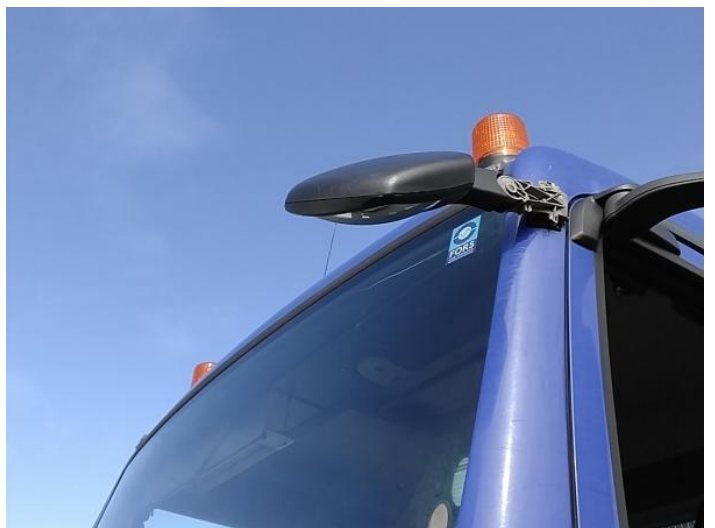
8: Door Mirror Assy nsf  
Missing  
Replace

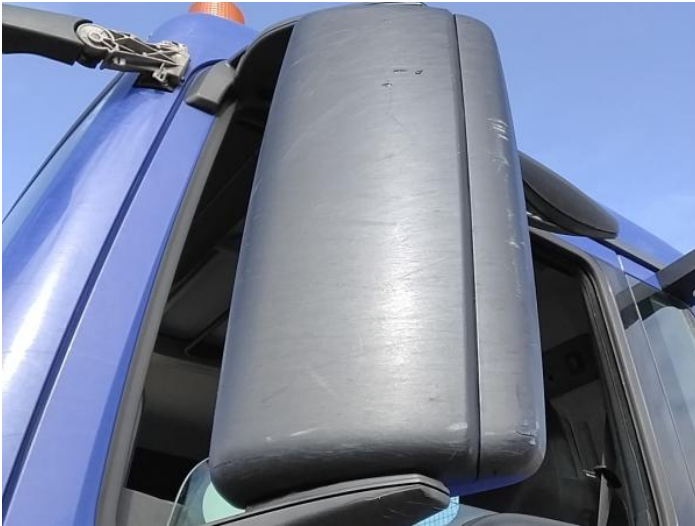
9: Door Mirror Assy nsf  
Scuffed (Unpainted)  
UpTo 100mm

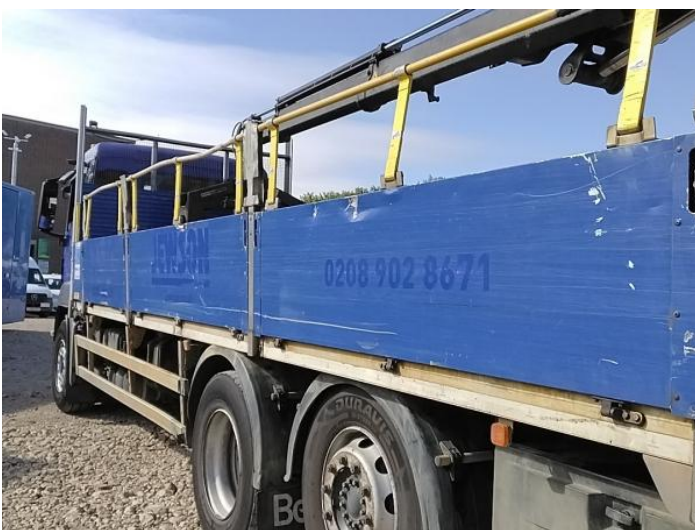
13: Qtr Panel nsr  
Dented  
Over 30mm

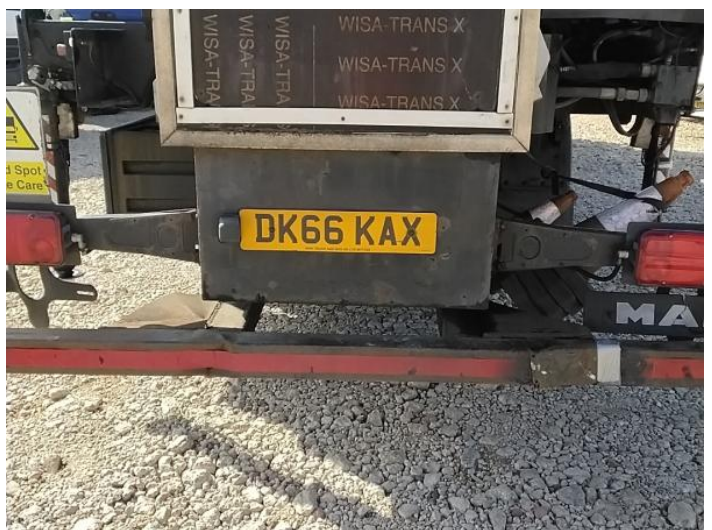
14: Bumper Rear  
Rusted  
Over 5mm

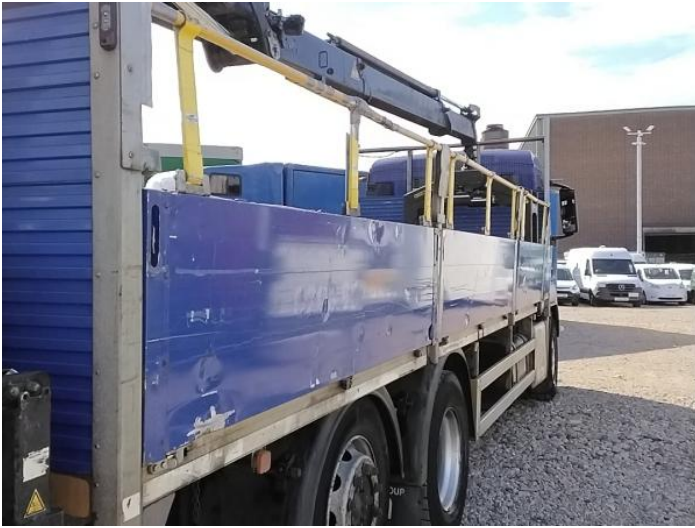
15: Qtr Panel osr  
Dented  
Over 30mm

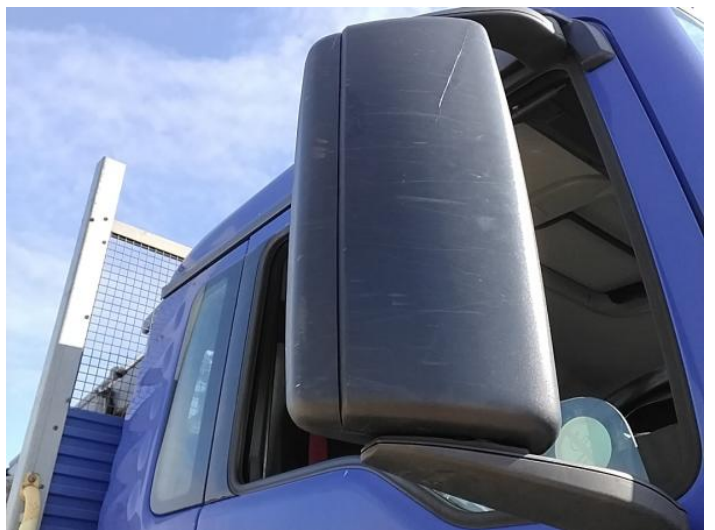
20: Door Mirror Assy osf  
Scuffed (Unpainted)  
UpTo 100mm

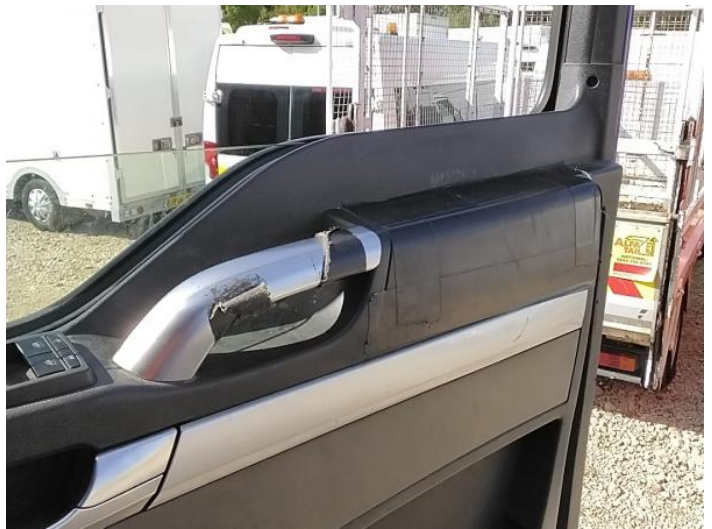
22: Door Pad osf  
Broken  
Replace
